# ANNUAL REPORT FOR 2015

**Bald Creek Site #8 Mitigation Site**  
**Yancey County**  
**TIP No. R-2518B**  
**COE Action ID: SAW-2007-2197-357/300**  
**DWR #: 20071134**

Prepared By:  
Natural Environment Section & Roadside Environmental Unit  
North Carolina Department of Transportation  
November 2015

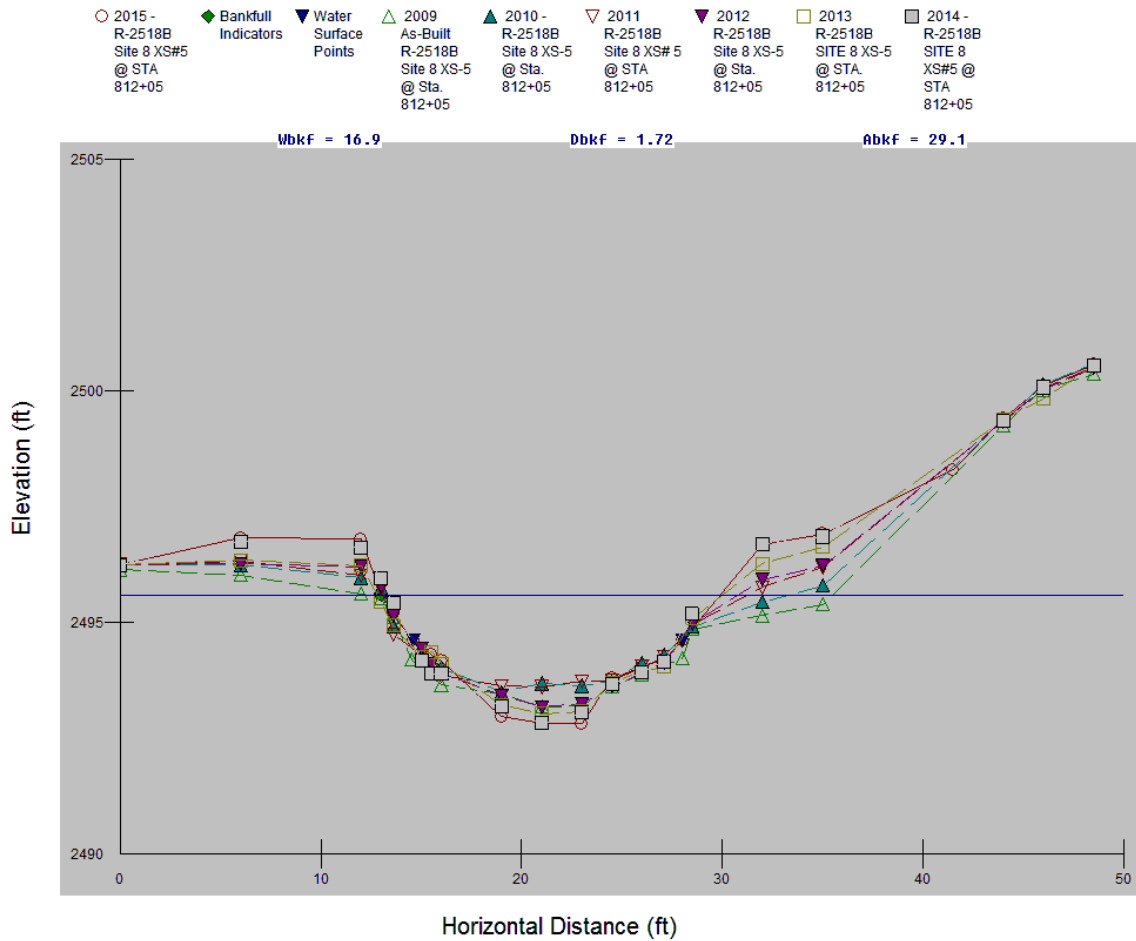
### R-2518B Site 8 XS#5 @ STA 812+05

Based on comparisons of the As-Built to the monitoring data, all of the cross sections appear stable with little or no active bank erosion. Graph of the Cross Section #5 is presented in Appendix A. Future survey data will vary depending on actual location of rod placement and alignment; however, this information should remain similar in appearance.

Site #8: Cross-Section #5 (Pool) Abbreviated Morphological Summary*						
	2010	2011	2012	2013	2014	2015
Bankfull Cross Sectional Area (ft <sup>2</sup> )	29.34	28.13	31.18	25.67	34.43	29.13
Maximum Bankfull Depth (ft.)	2.25	2.11	2.62	2.41	3.11	2.78
Bankfull Mean Depth (ft.)	1.36	1.49	1.69	1.55	2	1.72
Bankfull Width (ft.)	21.57	18.82	18.48	16.54	17.25	16.91

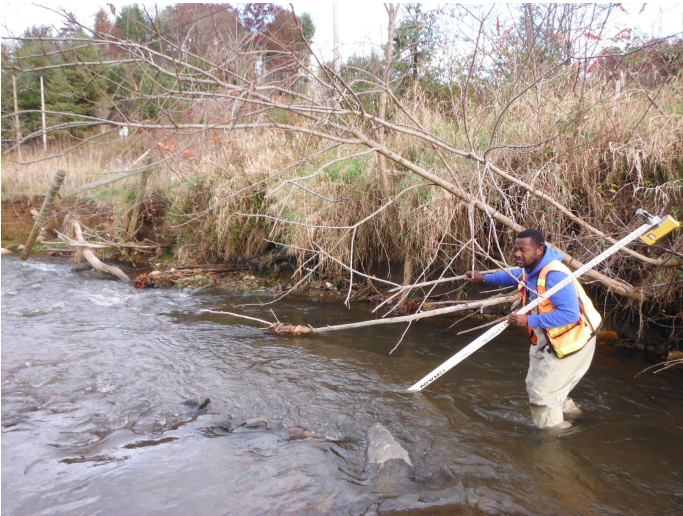
The Bald Creek Site #8 Mitigation Site has met the required monitoring protocols for the sixth formal year of monitoring on the stream and the fourth formal year of monitoring on the planted vegetation. The channel is stable throughout, except for, the right bank just downstream of Cross Section #5 which is eroding. NCDOT plans to repair this bank in 2016. The planted vegetation is surviving at this time.

Right bank eroding downstream of Cross Section #5  
November 2015

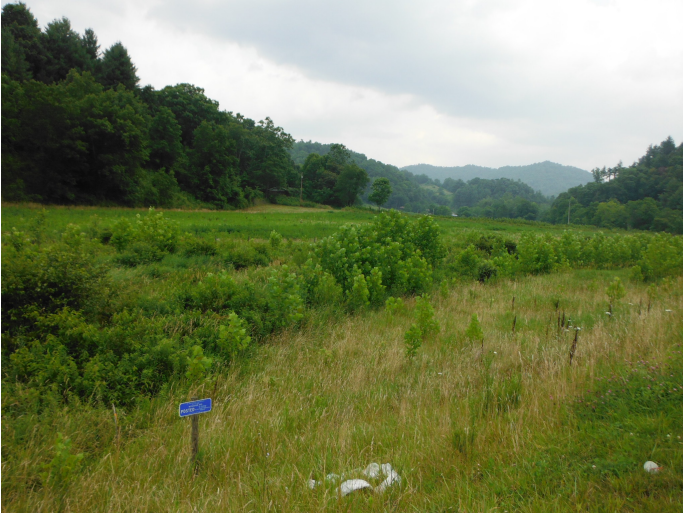
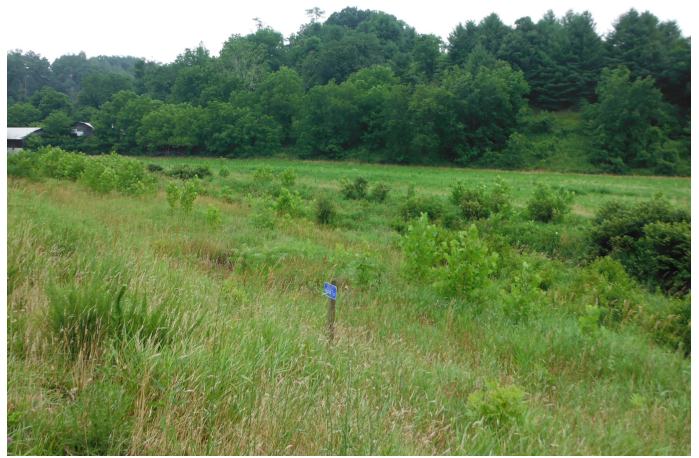
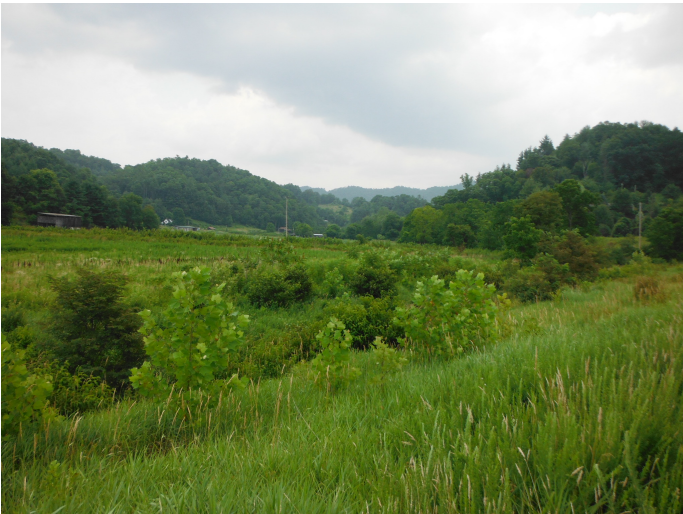
Vegetation Overview Photo

**Streambank & Buffer Vegetation:** The streambank reforestation was completed in March 2012. The Year 4 vegetation monitoring evaluation noted: Type I: Black Willow, Silky Dogwood and Type II: Sycamore, Green Ash, Tulip Poplar and White Oak were surviving at the time of the monitoring evaluation.
